DTO28 lifts saved!

**STOP** Rotary DTO28 equalizer box cave-ins from causing premature and costly lift replacement.

SVI's *Drop-In Rack and Pinion Equalizer Upgrade Kit* is the solution DTO28 lift owners have been seeking.

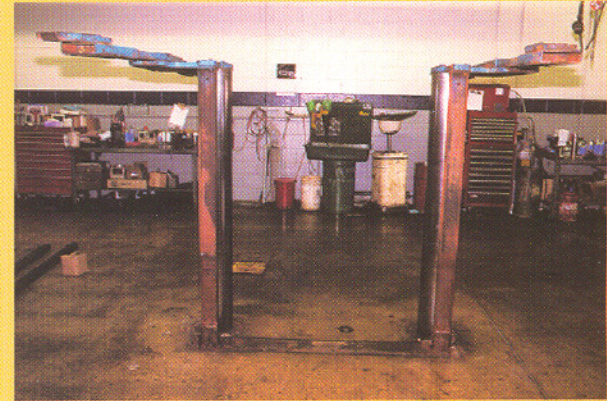
This DTO28 was raised nightly for floor cleaning. One day it just simply would not go back down.

This kit provides DTO28 lift owners with a real service solution. Many DTO28 lifts have one problem in common, the equalizer box corrodes and begins caving-in. This condition causes the crossbeam portion of the existing equalizer mechanism to hang up and impair or completely stop the lifts function. While, there is nothing else wrong with the lift, lift owners in the past were faced with two costly options, replace the lift or excavate and install a new equalizer - **this is over!**

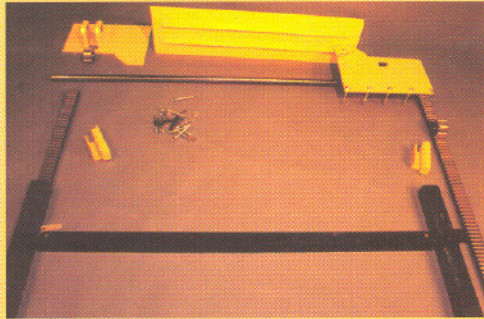
The new kit includes: racks bars, housings, pinions, guide tubes, locking system and all the hardware.

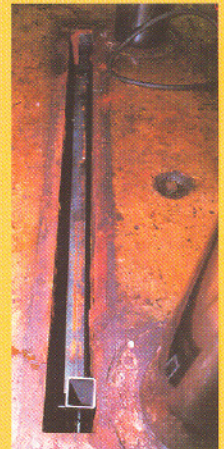
Sealed guide tube system shown lowered in place.
