Insist on only SVI "Direct Fit" brand Lift Repair Parts.

for lift models VLX6,
VLXS6,
VLX6-1, 2, 3 or 4

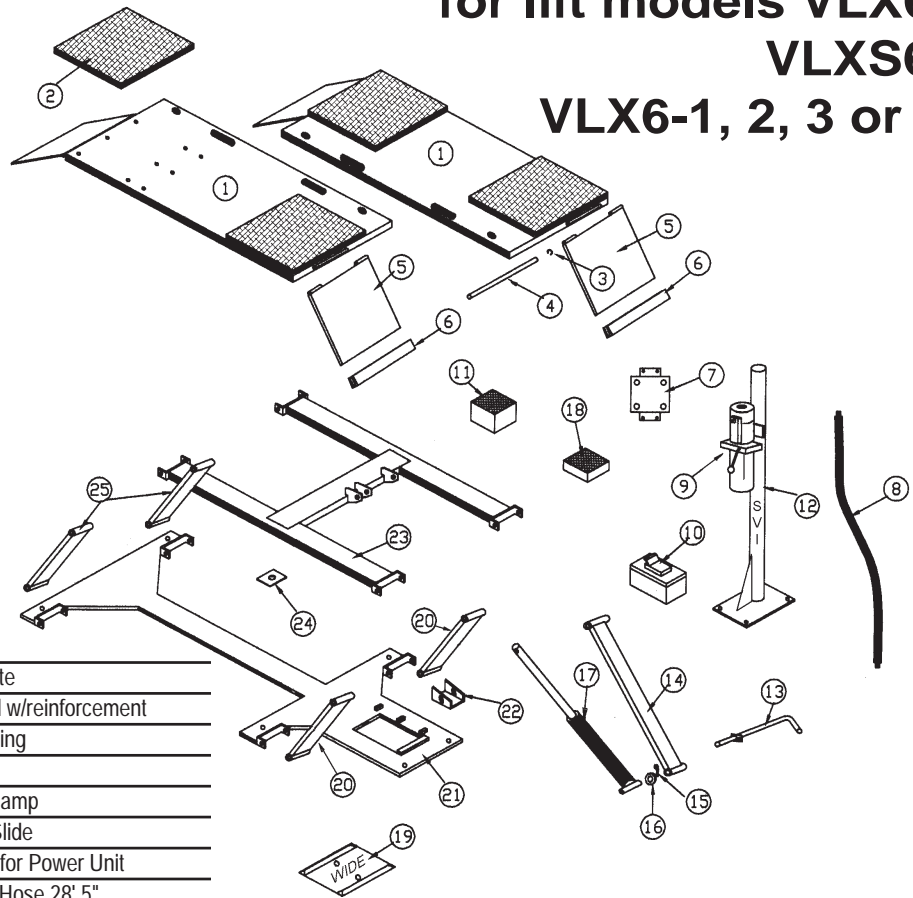
| Item | SVI part# | OEM# | Req | Description |
| 1 | BH-7546-001 | FJ2386-1 | 2 | Pick Up Plate |
| 2 | BH-7546-002 | FJ2433 | 4 | Rubber Pad w/reinforcement |
| 3 | BH-7546-003 | FJ2334 | 4 | Retaining Ring |
| 4 | BH-7546-004 | FJ2388 | 2 | Hinge Pin |
| 5 | BH-7546-005 | FJ2387 | 2 | Approach Ramp |
| 6 | BH-7525-22 | FC5142-3 | 2 | 14" Ramp Slide |
| 7 | BH-9785-45 | T120020 | 1 | Wall Mount for Power Unit |
| 8 | BH-7512-17 | FJ85 | 1 | Power Unit Hose 28' 5" |
| 9 | BH-7007-01 | P833 | 1 | Power Unit |
| 10 | SF-22903 | P831 | 1 | Pump for air operated models |
| 11 | BH-9756-87 | FJ2428 | 4 | 3" Tall Rubber Block |
| 12 | BH-7537-34 | FJ864 | 1 | Power Unit Stand (one unit) |
| | BH-7537-34D | FJ570 | 1 | Power Unit Stand (two unit) |
| 13 | BH-7546-006 | FA2390 | 1 | Lock Release Handle |
| 14 | BH-7546-007 | FJ2458 | 1 | Lock Leg |
| 15 | F-CP-125-1250 | | 1 | 1/8" x 1-1/4" Cotter Pin |
| 16 | BH-7546-008 | FJ2252-4 | 1 | Washer |
| 17 | BH-7505-02 | FJ2248 | 1 | Hydraulic Cylinder |
| | BH-7532-85 | FJ2248-12TH | | Seal Kit for Texas Hyd Cylinder |

| Item | SVI part# | OEM# | Req | Description |
|---|---|---|---|---|
| 18 | BH-9756-86 | FJ2427 | | 1-1/2" Tall Rubber Block |
| 19 | BH-9701 | SVI Exclusive | 1 | 15" Wide Reach Wheel Spotter |
| | BH-9702 | SVI Exclusive | 1 | 15" Wide Reach Dual Spotter |
| 20 | BH-7546-010 | FJ2244 | 2 | Front Lift Leg |
| 21 | BH-7546-011 | FJ2370 | 1 | Mounting Plate |
| 22 | BH-7546-012 | FJ2293-1 | 1 | Cylinder Retainer |
| 23 | BH-7546-013 | FJ2459 | 1 | Superstructure |
| 24 | BH-7546-014 | FJ2392 | 4 | Retainer |
| 25 | BH-7546-015 | FJ2245 | 2 | Rear Lift Leg |
